THERMO-HYDRAULIC
TESTS WITH WYOMING
BENTONITE AT HIGH
TEMPERATURE (PROJECT
EURAD-HITEC)

Villar Galicia, M.^a V.
García Herrera, G.
Iglesias Martínez, R.J.
Gutiérrez Álvarez, C.
Martín Martín, P.L.
Barcala Riveira J.M.

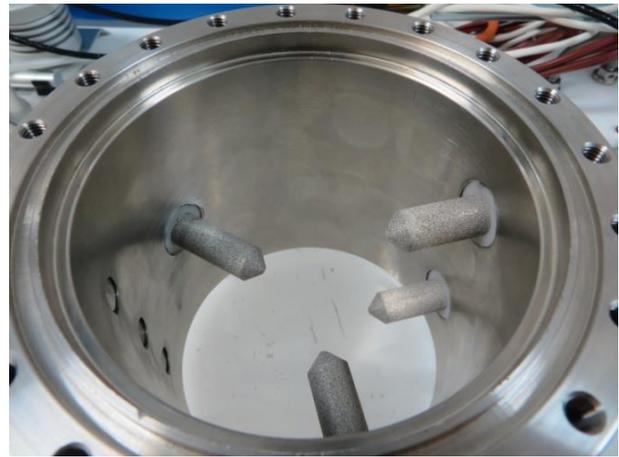
Figure 4. Cross-section of a cell, with indication of the location of the RH/T and pressure sensors (left), and internal view of the cell with the sensors inserted through the acetal rings (x stands for the cell number: 1 or 2)

The cells were instrumented with capacitive-type sensors placed inside the clay at three different levels (25, 50 and 75 mm from the heater, Figure 4). The transmitters used were VAISALA HMT337 (Figure 6), which include a humidity sensor (HUMICAP®) that changes its dielectrical characteristics with extremely small variations in humidity (capacitive-type RH sensor). They include also a temperature sensing element (Pt 100). The accuracy of the humidity sensor is $\pm 1\%$ over the range 0-90 percent RH and $\pm 2\%$ over the range 90-100 percent RH. The sensors are protected by cylindrical stainless steel filters (HM47280SP, length 41.5 mm). The Vaisala sensors integrate the measurement in a volume of 3.6 cm³, 1.2 cm in the axial direction of the cell.

Radial pressures on the lateral surface of the bentonite block were measured at the same distances from the heater as those for the RH/T transmitters (i.e. 25, 50 and 75 mm, Figure 4). Two types of miniature pressure sensors with isolated diaphragm were installed, depending on the distance to the heater. The closer one was a XPC10 high temperature sensor, the two others were XPM10. Their characteristics are shown in Table 2 and their cross-section and dimensions are shown in Figure 9.

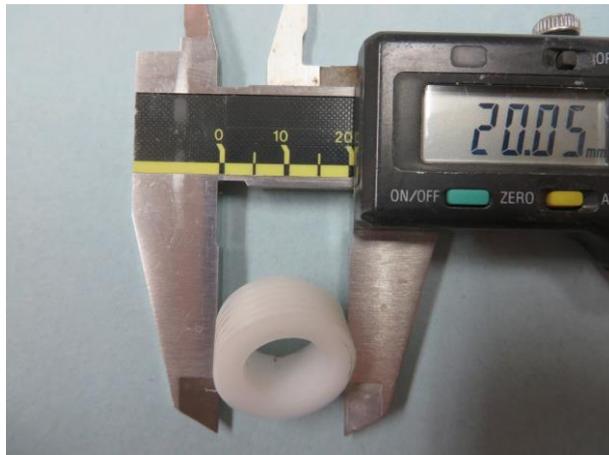
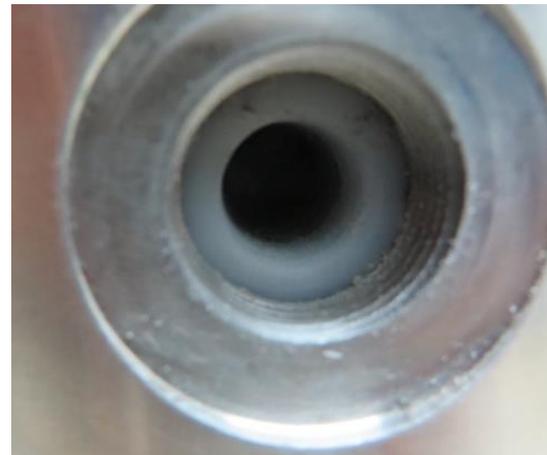
Threaded hollow pieces of white acetal were installed in the RH/T sensors' inlets (Figure 5). These pieces were aimed to ensure a horizontal sensor socket and a good connection between the inner walls of the cell and the area where these sensors were located, giving continuity to the internal walls of the cell and providing thermal insulation.

Figure 5. Acetal threaded ring once inserted in the sensors' inlet

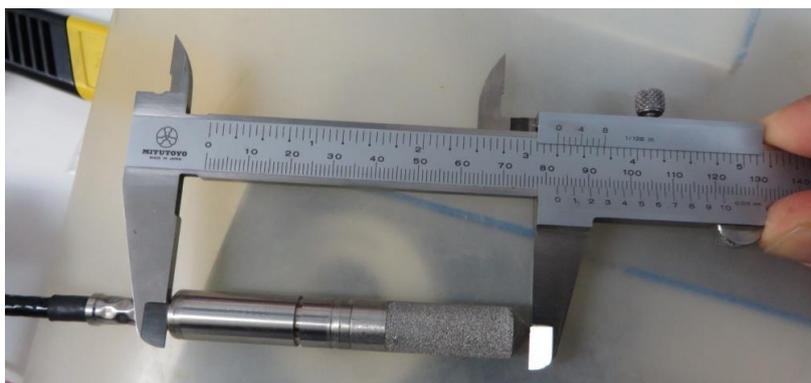
Figure 6. Vaisala HMT337 relative humidity sensor

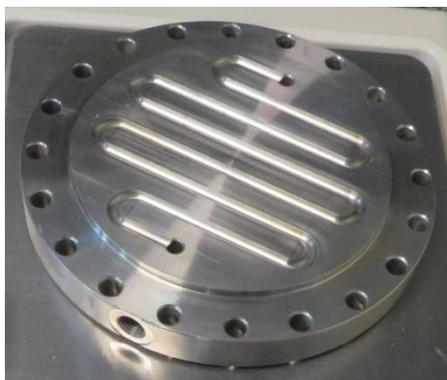
Figure 11. Bottom surface of the upper lid of the cell with machined groove and water inlets

The hydration system was designed to supply water for hydration of the bentonite and at the same time measure the water intake. Each cell had its own independent hydration system. The hydration water was injected to the cells through the upper hydration line (blue lines in Figure 3) that crossed the upper lid of the cell. This lid has a continuous groove machined on its down surface to help a better water distribution (Figure 11), which was further facilitated by the use of a stainless steel porous filter placed on top of the sample. The filters were ultrasound-cleaned before their use.

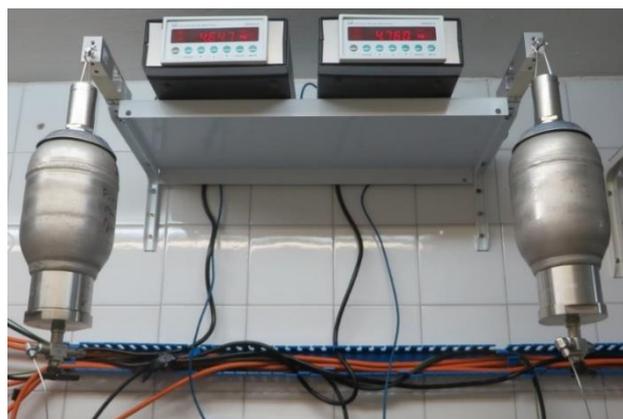
Figure 13. Hydration system: accumulators, load cells and amplifiers

The amount of water entering the system was measured by weighing the accumulators. The accumulators hanged from load cells to control the mass of the water supplied to the cells. The weighing system for each cell consisted of the following elements (Figure 13):

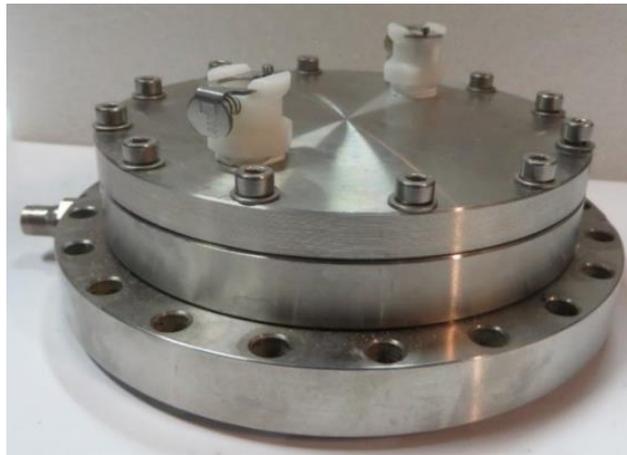
The upper part of the cell includes a cooling chamber of an approximate volume of 93 cm³, closed by a bolted cover (Figure 19).

Figure 19. Cooling chamber

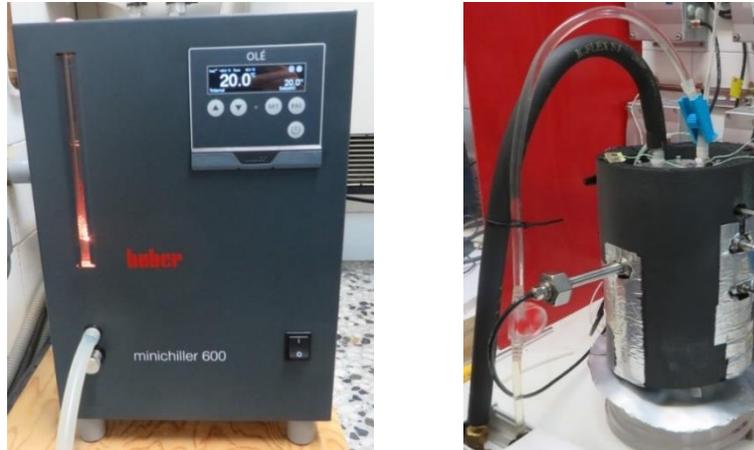
The cooling fluid, water at 20 °C, was impelled and circulated by a Huber Minichiller 600 OLÉ (-20/+40 °C, ± 0.5 °C, 600 W at 15 °C, 18 L/min) through two lines, connected to two drills in the cooling chambers, inlet and outlet, by two quick-couplings (green lines in Figure 3). The arrangement of the system for cooling fluid circulation is shown in Figure 20. This minichiller was used for several cells in addition to the two HITEC cells. The chiller had to be changed on September 2021 by a Huber Minichiller 300-NR (-20/+40 °C, 300 W at 15 °C, 14 L/min) that was subsequently used only for the two HITEC cells.

Figure 20. System for cooling fluid circulation: minichiller (left), inlet/outlet to the cells (right)

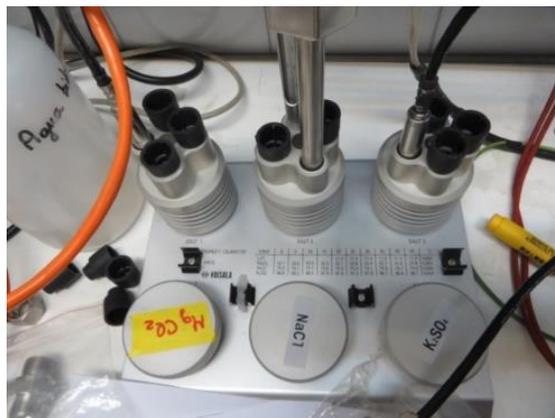
All new VAISALA sensors were calibrated by the manufacturer, only the refurbished Vaisala sensors (they were used ones with replaced new capacitive elements) were calibrated for both humidity and temperature (four refurbished sensors were placed in Cell 1 and one in Cell 2). For this purpose, a Vaisala humidity calibrator HMK15 was used (Figure 27) and the following procedure was applied:

Figure 27. Setup for calibration of the RH/T Vaisala sensors

1. In HMK15, three solutions of $MgCl_2$, $NaCl$ and K_2SO_4 were prepared according to instructions of the HMK15 user's manual.
2. The sensor filter was removed, the sensor was attached to an adapter supplied with the HMK15 and inserted into the $MgCl_2$ tank taking care that it did not touch the liquid.
3. The thermometer supplied with the HMK15 was placed in another hole in the adapter.
4. The adapter has four holes so three sensors could be calibrated simultaneously (the 4th hole is for the thermometer).
5. A PC was connected to the Vaisala electronics service port using the RS232 serial cable.

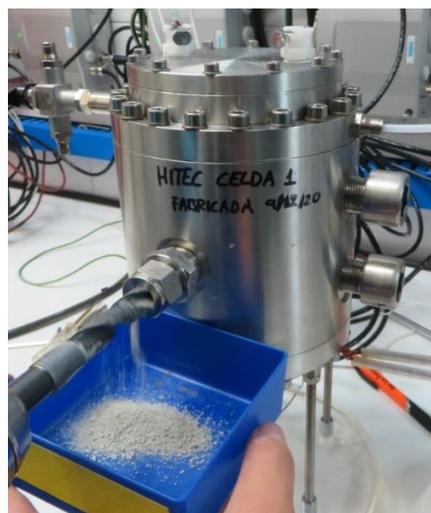
Figure 31. Drilling of holes through a threaded nut with a 12-mm drilling bit for insertion of the RH/T sensors

12-mm drilling bit was used. The depth to which the bit was pushed inside the bentonite was that of the sensor. During drilling, as much material as possible was recovered and weighed (Figure 31). The dry density of the bentonite block was then recalculated taking into account the volume occupied by the sensors and the material extracted during drilling.

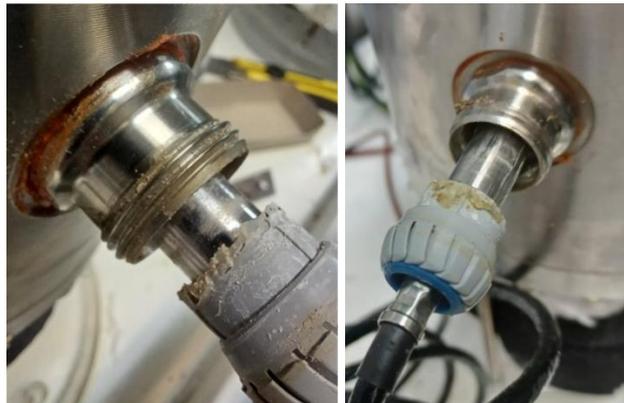
After a cooling period of 60-90 minutes, the relative humidity sensors were inspected. In some of them the sealing elements were clearly broken or deteriorated. Water drops and even bentonite were observed in some of them, which confirmed that these openings were leaking points (Figure 49).

Figure 49. Deteriorated cable gland (left) and bentonite around sensor RH/T13 in cell HT1 (right)

The RH sensors' inlets were sealed with Nural 28 silicone at all possible places (Figure 50).

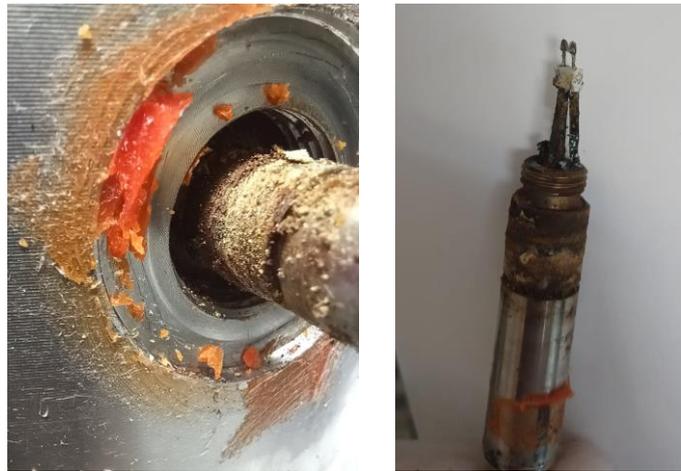
Figure 58. Extraction of sensor RH/T12 and sensing element once extracted

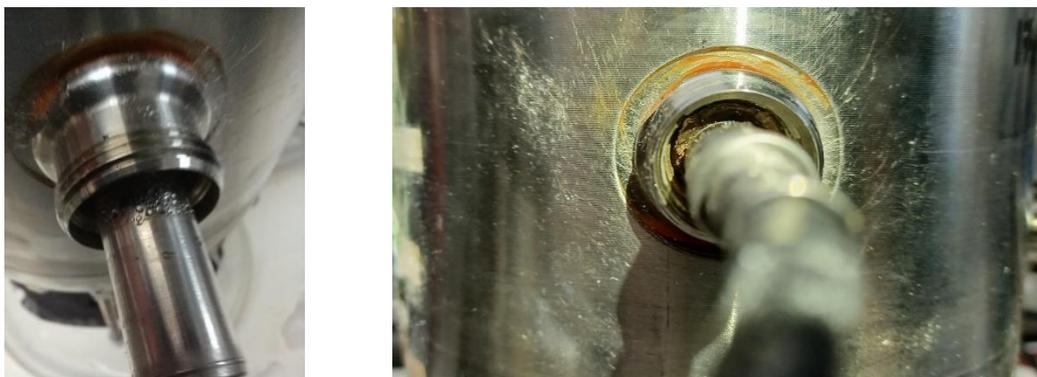
Figure 74. Water drops and bentonite around sensor RH/T22

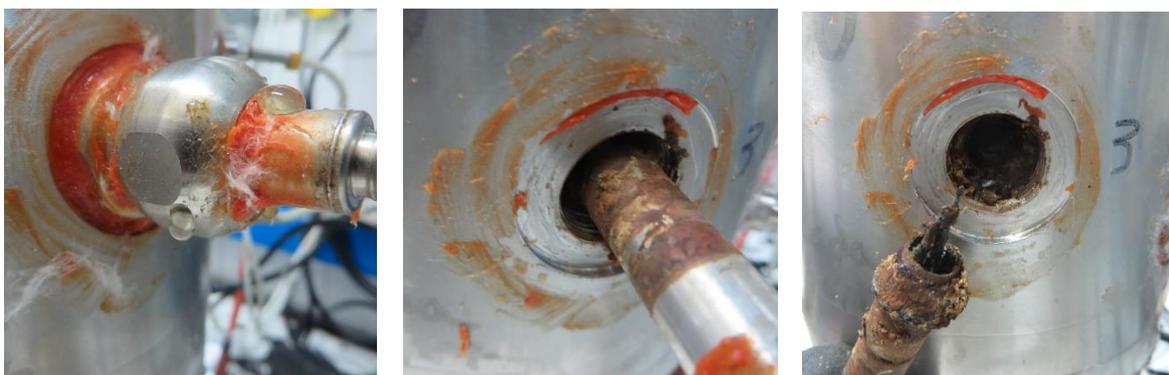
Figure 87. Extraction of sensor RH/T13

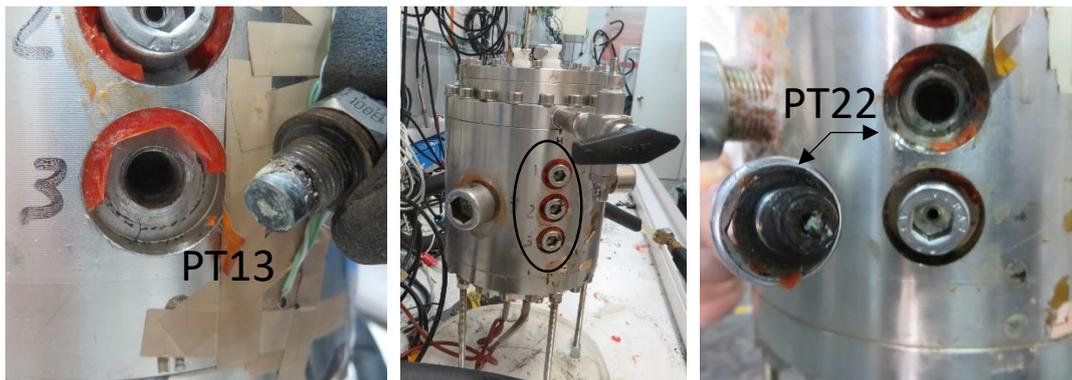
7. Removing the pressure sensors (Figure 88) and closing of the openings with screws.

Figure 88. Extraction of pressure sensors (left: PT13; middle: all PT1x closed with screws; right: PT22, whose screw was not easy to turn)

The sensing elements of the RH/T sensors had been removed in July 2022 (420 day of hydration), hence only the filters were inside the bentonite. The pressure sensors were removed at the beginning of the dismantling works and found very deteriorated (Figure 88), except for sensor PT23, which was only corroded. Their housings on the cell external wall were clean. It was not possible to extract the filters of the RH/T sensors from the bentonite and they had to be retrieved when the block was sliced for sampling.

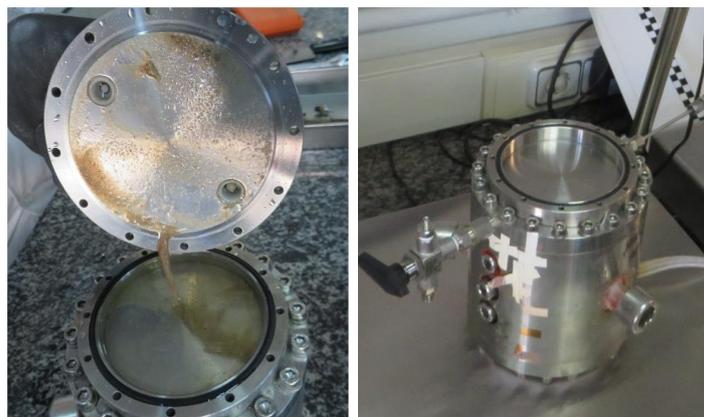
Figure 89. Emptying of the cooling chamber and weighing of cell HT2

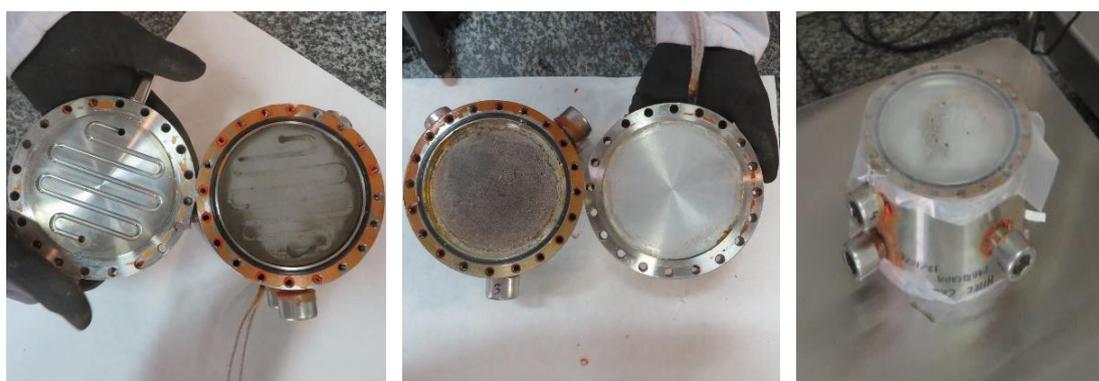
Figure 91. Opening of the hydration (left) and heater (middle) lids in cell HT1. Weighing of cell HT2 (right)

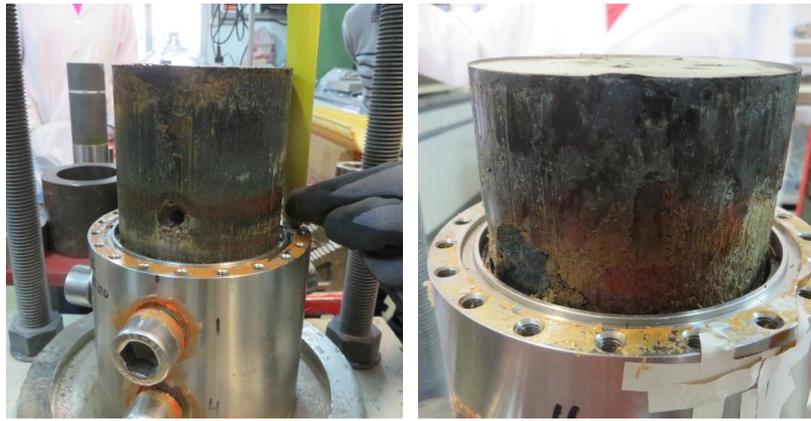
16. Extracting the sample by pressing with a piston from the bottom surface of the sample (Figure 92). Note that the block was able to move upwards during extraction and the pressure applied during this process was much smaller than the compaction pressure, hence no impact of this procedure on the physical state of the block is expected. However, the bottom part of cell HT2 remained stuck to the cell wall (see below in subchapter 8.2).

Figure 92. Extraction of samples HT1 (left) and HT2 (right) by pushing from the bottom

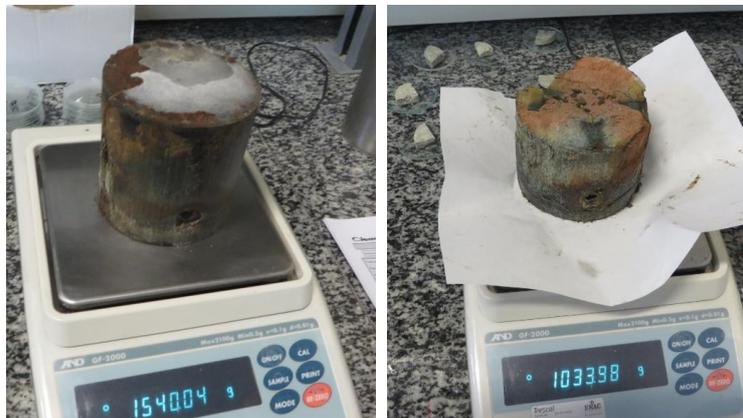
17. Weighing and measuring the bentonite block (Figure 93). Immediately wrapping it with plastic film to preserve water content.

Figure 93. Weighing of entire block of cell HT1 (left) and cohesive part of HT2 (right)

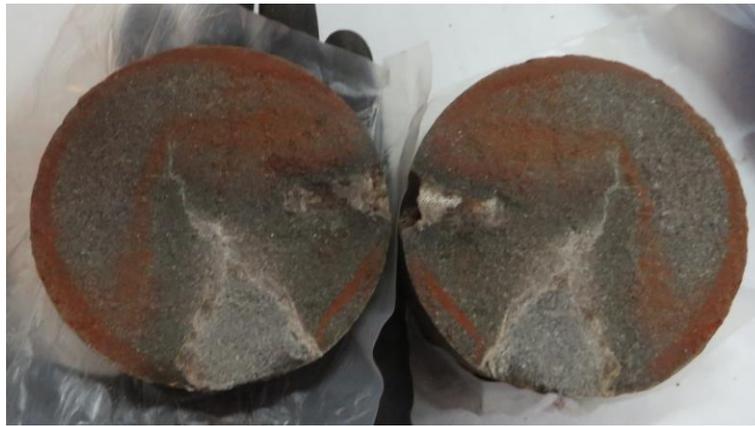
Figure 96. Corrosion halos between sections 1 (left) and 2 (right) of cell HT1

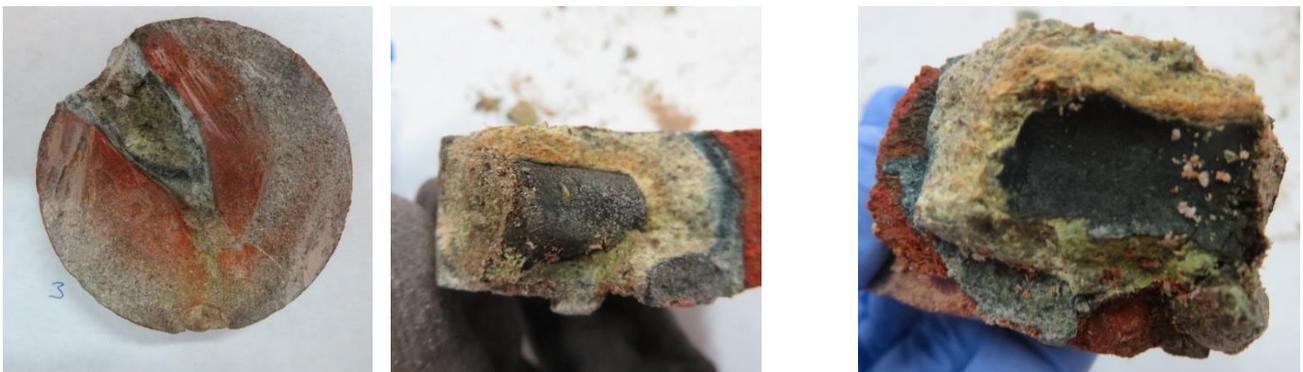
Figure 97. Halo around sensor RH/T14 (left) and RH/T13 (middle, right)

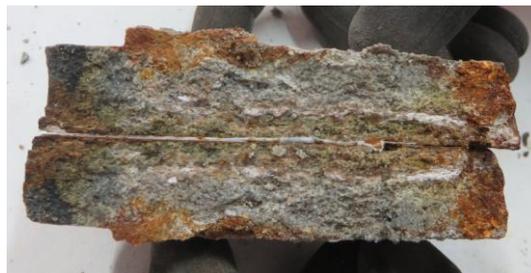
In sampling section 1 (the one on top), a thin white crust at ~6 mm from the heater was observed (Figure 98) and sampled. It very soon disappeared.

Figure 98. Thin white crust at ~6 mm from the hydration surface of cell HT1 (section 1 was transversally cut and the photo shows the two halves superimposed with the filter paper between them and the white crust above and below)

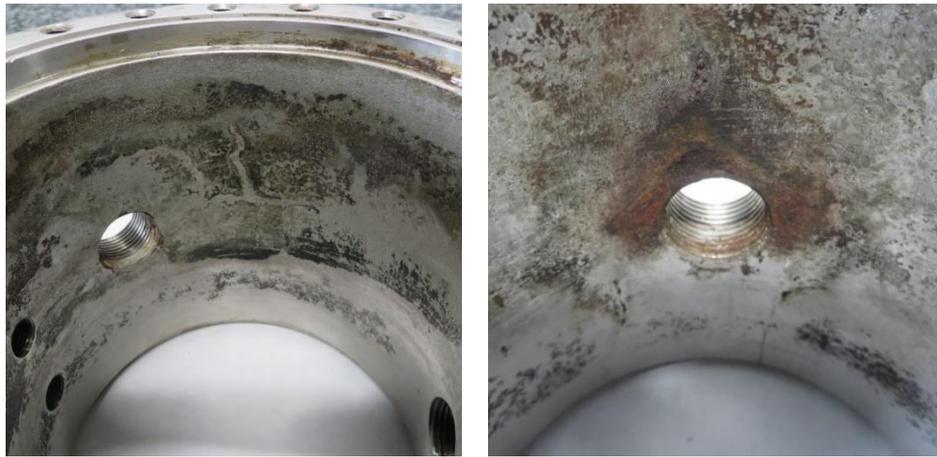
Figure 99. Appearance of the internal surface of cell HT1 just after having cleaned it. On the right-hand side, a corrosion halo around sensor RH/T12 can be seen

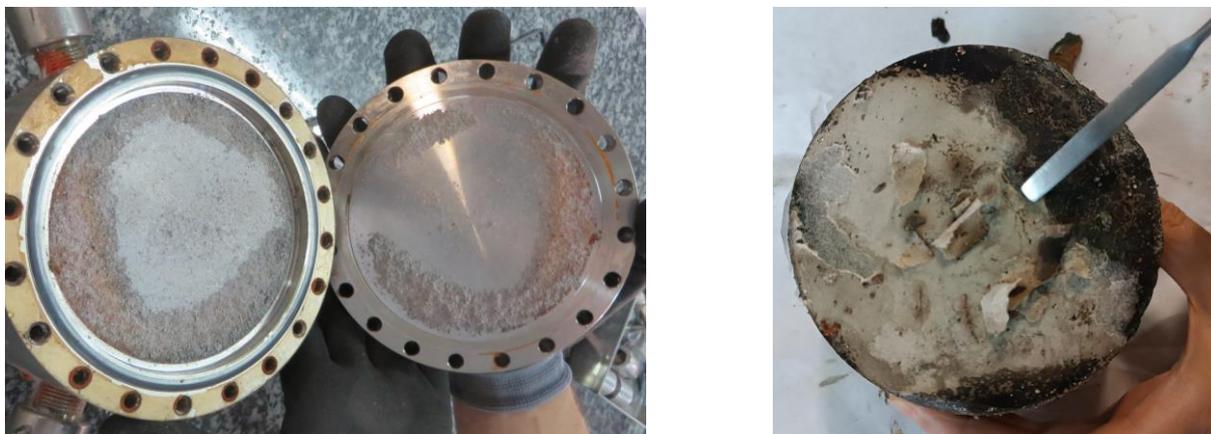
Figure 101. Bottom of the bentonite block HT2 and heater surface upon dismantling (left) and top of block with filter paper (right)

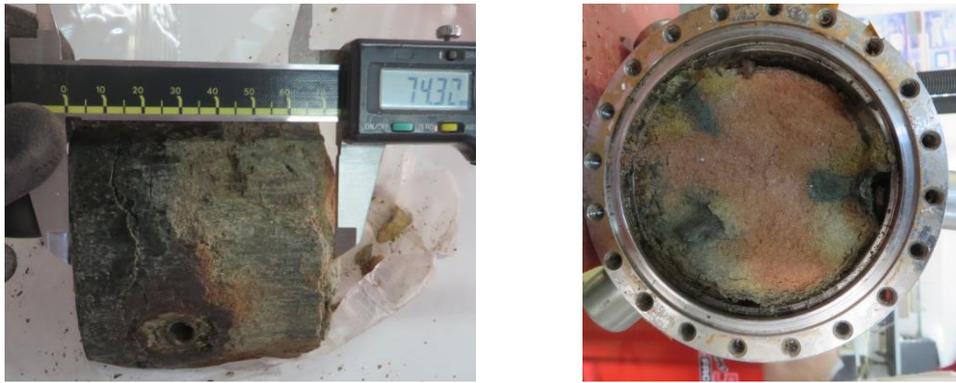
Figure 102. Cohesive part of block HT2 extracted from the cell (left) and upper appearance of the part of the block remaining inside the cell (right)

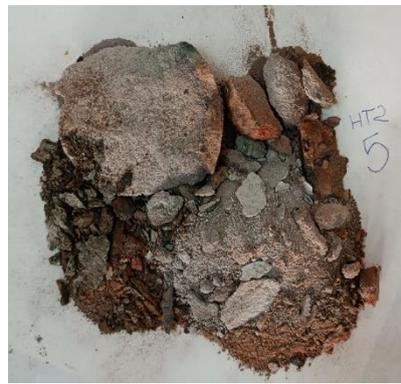
Once the lower lid of the cell was unscrewed, the bentonite was found very dry, stuck to the heater, and with a darker colour in the periphery (Figure 101, left). The o-ring on the heater lid was flattened and somewhat rigid, but still flexible. The filter paper on top of the block was stuck to the bentonite and could not be totally detached (Figure 101, right). The upper bentonite surface was very wet and dark, but no remarkable stains were observed. The block was extracted by pushing from the bottom applying a pressure of 6.4 MPa, but only the cohesive upper part could be extracted (Figure 92, Figure 93), because the block broke and the rest of it remained stuck to the cell wall (Figure 102). The surface along which the block broke was oxidised and presented black stains close to the sensors' inlets. The bottom part of the block (corresponding to sections 5 and part of 4, i.e. the ~4 cm closest to the heater) had to be sampled with a spoon and other tools because it was not consistent, although some fragments were like cemented (Figure 103).

Figure 103. Section 5 (2 cm closest to the heater) of the bentonite block of cell HT2

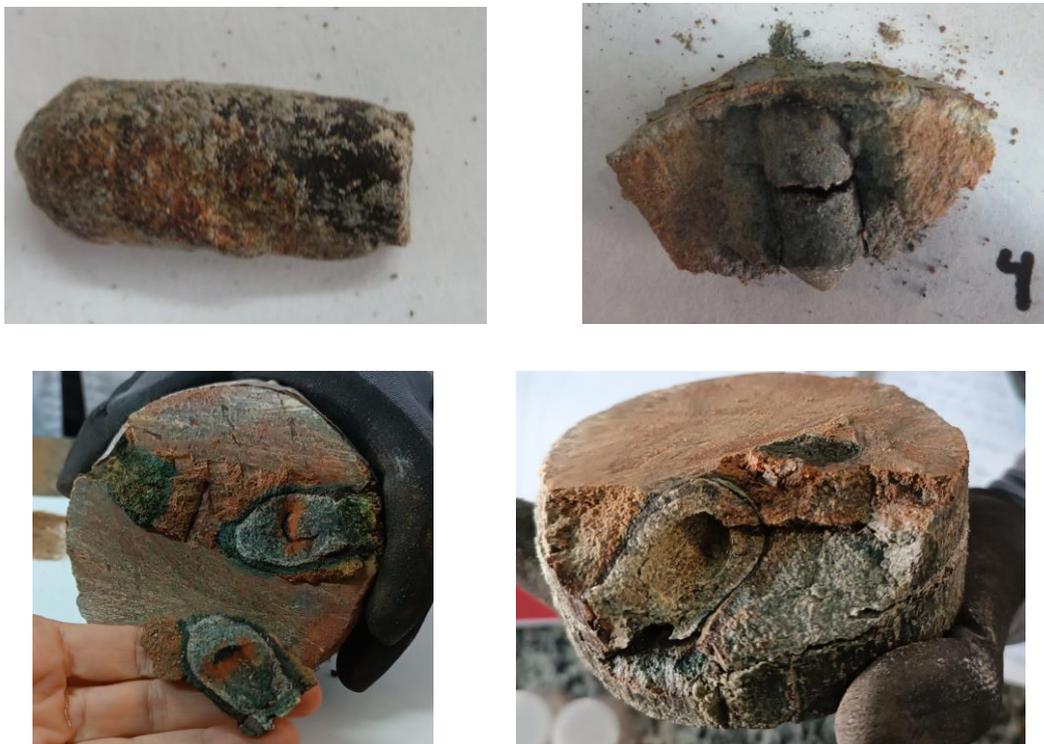
Figure 104. Appearance of filter of sensor RH/T21 (upper left), filter of sensor RH/T24 (upper right), corrosion halos and crusts around sensors RH/T22 and 23 (bottom left) and RH/T24 (bottom right)

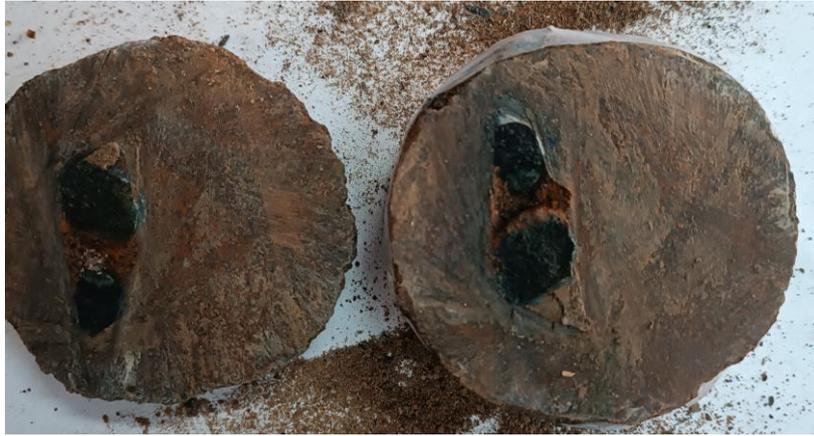
Figure 105. Surface at 6 cm from the heater in block HT2 (between sampling sections 2 and 3)

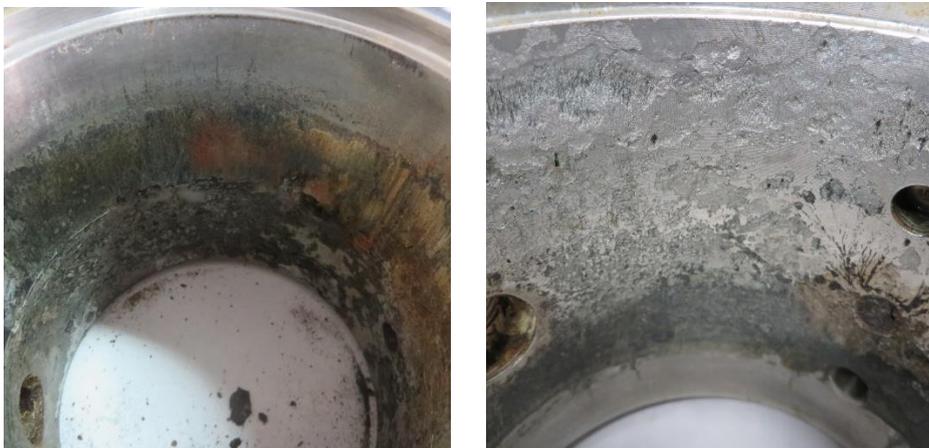
Figure 106. Appearance of the internal surface of cell HT2 just after block extraction (left, cell upside down) and after having cleaned it (right), showing important pitting corrosion
